# Case Study

## Intelligent Pigging of 13.5 km Multi-diameter Pipeline (4", 6", 8" Pipeline)

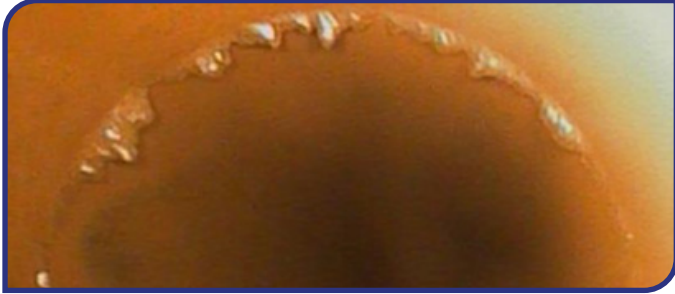
- Multiple heavy wall bends, which included an internal diameter of 132 mm
- 13.2 mm weld-penetrations in the 6" pipe sections
