# Case Study

## Pitting Detection During Furnace Inspection

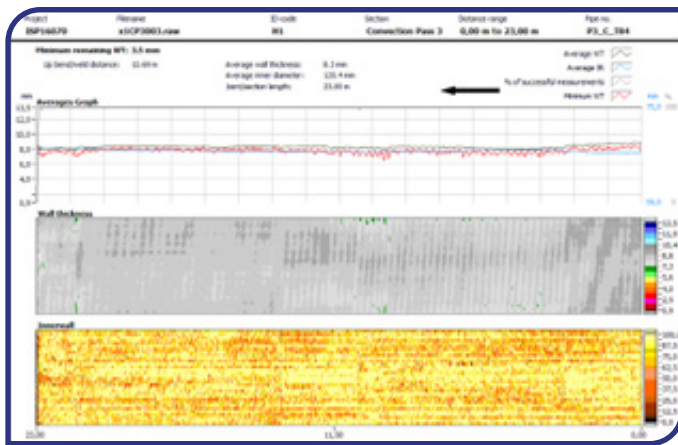
During the inspection of one of the furnaces, the initial data provided during the preliminary results did not show any major concerns (see below image).

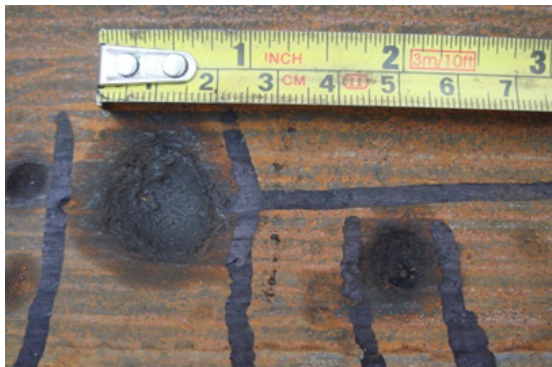
When assessing the data, our highly trained and certified (UT level 2) data analysts found local pitting using our recorded A-scan signal and advanced data analysis algorithms. Pitting corrosion is very unusual for these type of furnaces.

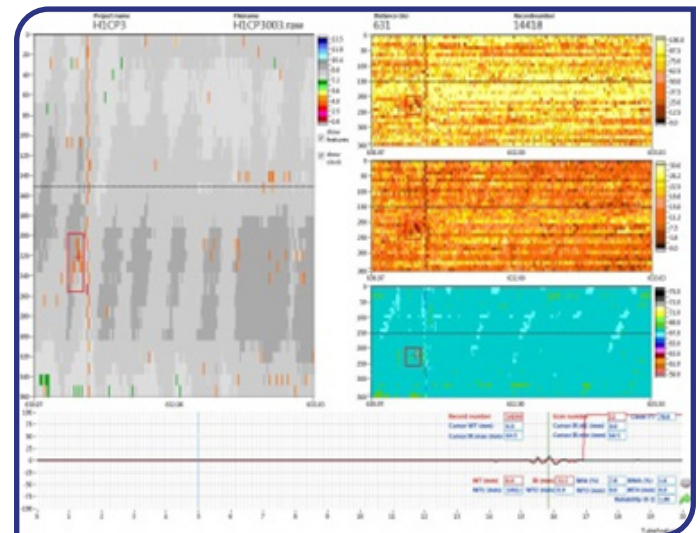
As the client didn't expect this type of corrosion mechanism inside the furnace, experts were called at the head office for a detailed review. With the colored, detailed data presentations from Intero's data analysis and reporting software (see below) the pitting degradation could be confirmed. The client decided to replace the tubes. After evaluation of replaced tube from the furnace, a 100% correlation with the reported data could be verified.
