# Case Study

## Aviation Jet Fuel Pipeline Supply Line Cleaning & Inspection with XYZ Mapping

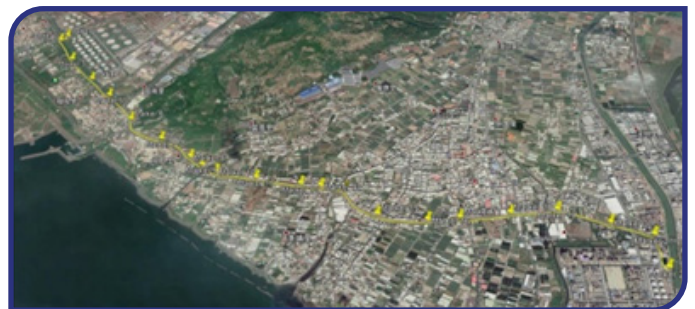
## Above Ground Marker Locations

Intero's well-trained team of engineers arrived, and began cleaning and piggability proving operations. They culminated by launching a dummy tool as a final verification of pipeline piggability. Simultaneously, the aboveground survey crew placed and surveyed the reference markers for the XYZ data collection.
