# Case Study

## Vopak Singapore: Tank Bottom Inspection of an In-Service Naphtha Storage Tank

- Scope: Online tank bottom inspection
- Object details: 10,000 cbm naphtha, 25.4 m diameter, fixed roof, 24-inch manway entrance
- Location: Sebarok Terminal, Singapore
- Customer: Vopak

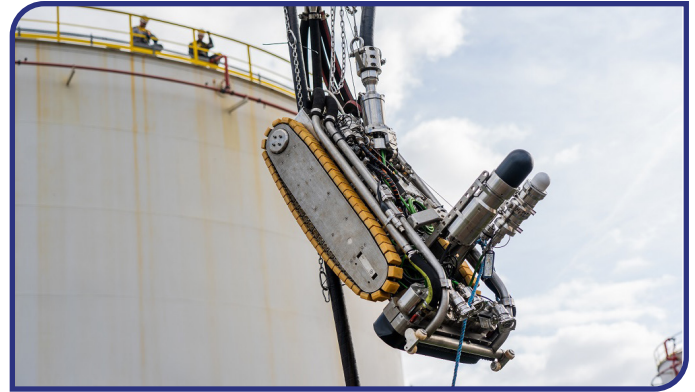
Once the robot was deployed, several reconnaissance runs were completed. During these reconnaissance runs, observations of sediment and sludge on the tank bottom were made with the cameras of the ROV.

- Low flashpoint product
- Close cooperation and coordination between all stakeholders
- Sediment / sludge layers up to 30 cm consisting of fine rust particles
- A limited timeframe to perform the inspection

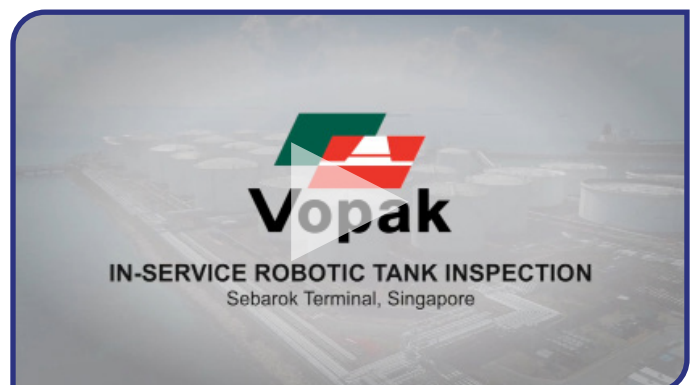
Smart tank terminal: robot inspection in Singapore

The second main objective was to perform an online tank bottom inspection. After the deployment, a significant sediment layer was detected. This sediment layer impeded the inspection and resulted in reduced coverage of the tank bottom to be inspected.
