# Case Study

## Heater Inspection of Plug Headers: Flexibility, Engineering, and Data

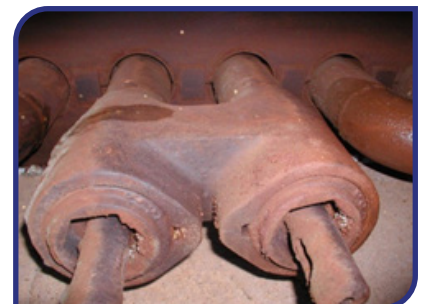
Most operators and service providers can easily clean and inspect standard heaters with a single diameter tubes and u-bends. More specialized configurations such as plug headers, boxes, horseshoes, and reducers require more detailed evaluation and planning.

For example, prior to carrying out this inspection at our client's refinery, Intero built a test loop at our research and development facility in Tricht, The Netherlands. Our customer was not able to provide the original plug header, so we designed a replica version with identical internal dimensions. We then performed test inspections to prove passage through the plug header bend with the modified Intero inspection tool.
