# Addressing Dents in Difficult-to-Inspect Natural Gas Pipelines: Enhancing Safety and Integrity with Robotics, Laser Technology, and Advanced Analytics

<sup>1</sup> Enbridge Gas Inc., <sup>2</sup> Intero Integrity Services Canada Inc.,

*Proceedings of the 2025 Pipeline Pigging and Integrity Management Conference.*

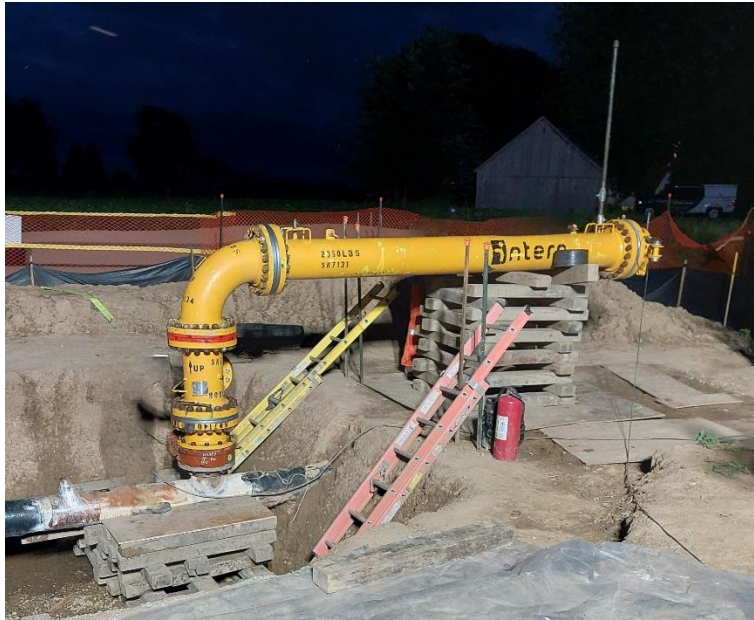
Hot tap fittings were installed at each designated location. Once ready for inspection, Intero's temporary launcher was erected, robot loaded into the barrel, equalized, and launched. The launch & receive setup is shown in Figure 5 & Figure 6. Intero operators controlled the Pipe Explorer robot to inspect 1,600ft (500m) out, and then return to the stopple fitting. Each inspection day, an additional 1,600ft (500m) of data was collected. This was repeated for 24 inspection days through

Figure 5. NPS 12 launch and receive site with Interro temporary launcher | Rural site
