## **LONG DISTANCE INLINE INSPECTION OF AN UNPIGGABLE NATURAL GAS PIPELINE WITH ROBOTIC TECHNOLOGY**

By: David Gian, Interro Integrity Services BV, Netherlands  
and Rod Lee, Interro Integrity Services BV, Netherlands

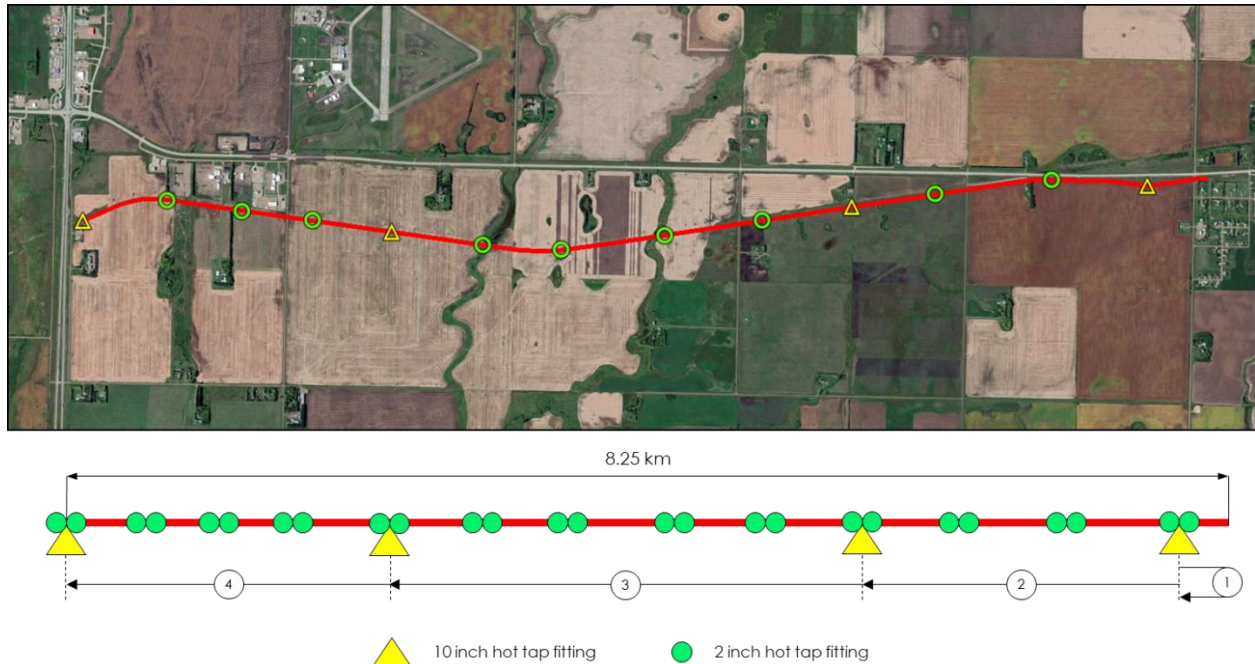
**Figure 4: Schematic of Brandon Lateral**

In order to address pipelines which do not have existing launchers and receivers the Pipe Explorer robots have been designed to launch through size-on-size hot tap fittings. In the case of the Brandon lateral, the pipeline operator installed four of these hot tap launch and receive sites over the entire length of the 8.3 km pipeline. Interro operators have the ability to either launch and receive from a single fitting (Out-and-Back) or launch at one site and receive at another (Point-to-Point) so, given the overall length of the line and the fittings that were installed on the pipeline, both methods would be utilized on the project. As outlined in Figure 4, Interro's Pipe Explorer 10/14 was launched and received at the same location one time at the east end of the pipeline and the remainder of the inspection was completed by travelling from launch site to launch site.

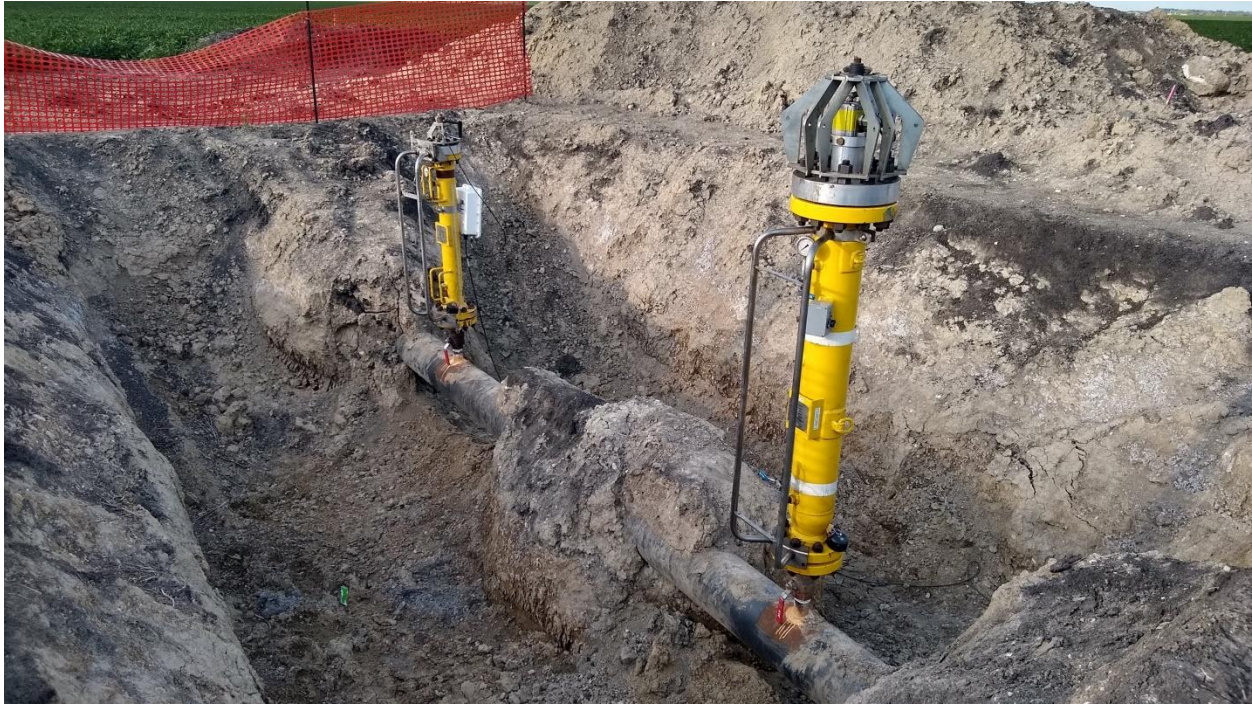
**Figure 5: In-line Charging Site on 10 inch Pipeline**

Since Pipe Explorer robots are battery powered, their initial inspection range is limited by the range capacity of the batteries on the unit. In an effort to extend the range of the Pipe Explorer fleet beyond this initial run, Intero implements a proprietary in-line charging (ILC) system which, in effect, adds “refueling” stations for the robot along the pipeline. Since these ILC points are smaller openings and require lighter fittings, the number of more costly size-on-size hot tap fittings can be reduced and the overall inspection time can be reduced from having to exit the line every time the batteries need recharging. In total, nine inline charging sites were utilized during the Brandon lateral inspection. An example of an ILC site is shown in Figure 5.

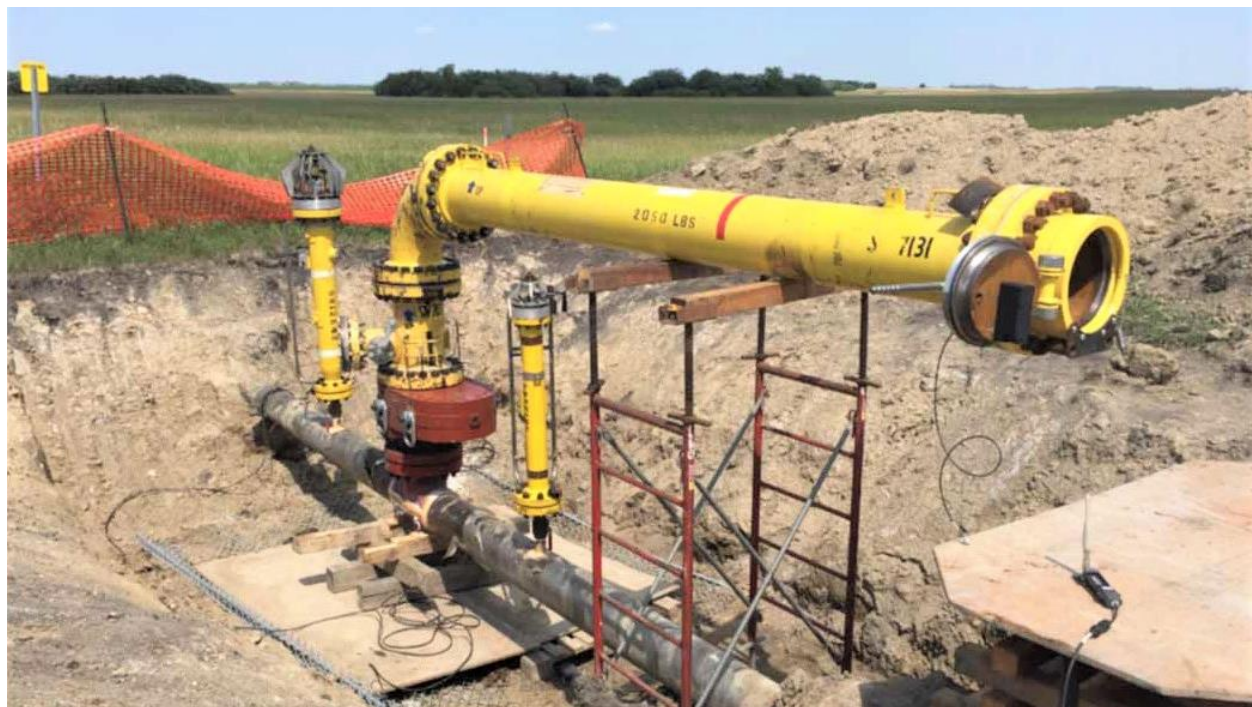
**Figure 6: Intero's Launch System for Pipe Explorer 10/14**

By utilizing this specialized in-line charging technology, pipeline operators are able to execute longer robotic inspections than would otherwise be possible. In the case of the Brandon lateral, the pipeline operator was able to leverage Intero's ILC such that the larger launch system, outlined in Figure 6, would be minimized to four locations on the line, resulting in reduced capital expenditure and a total onsite time of only nine days.
