# Case Study

## Ultrasonic Inline Inspection of Dual Diameter Pipeline (10", 12" Pipeline)

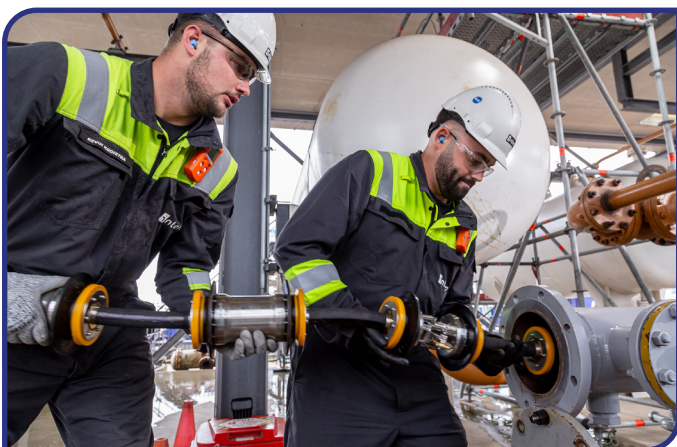
Intero's applications engineering team designed a custom configuration of the Pipeline Surveyor UT tool to navigate both diameters in a single pass. The tool's collapsible architecture allowed it to adapt seamlessly to diameter transitions while keeping sensors in precise alignment for accurate ultrasonic readings.

The engineering phase included detailed review of pipeline construction records, operational parameters, and previous inspection data. This was followed by in-house applications testing at Intero's Houston test loop facility, ensuring passability, verifying sensor centralization, and validating data integrity before deployment.
