## **INNOVATIONS IN IN-SERVICE ROBOTIC INSPECTION OF UNPIGGABLE NATURAL GAS PIPELINES AT RIVER CROSSINGS FOR WHICH THERE ARE NO EXISTING LAUNCHING AND RECEIVING CAPABILITIES**

**By David Gian, Interro Integrity Services B.V.**

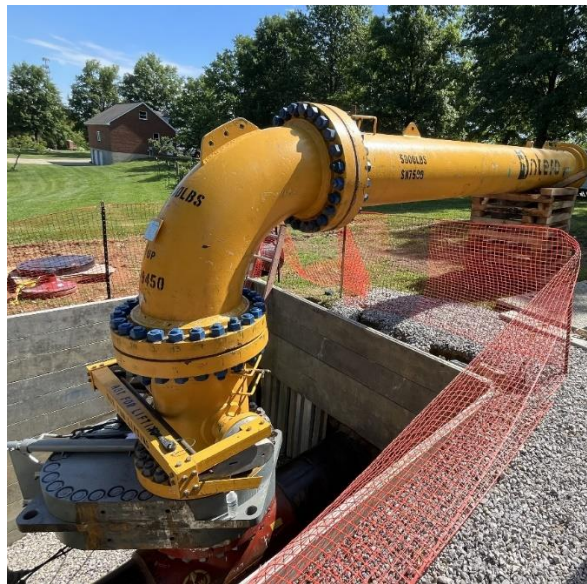
**Figure 5: 24" Launcher Set-Up**

These fittings are designed to allow the pipelines to remain fully operational during and after the installation process, which is crucial for minimizing downtime. A sandwich valve was installed atop each fitting, serving as a secure point for the attachment of pipe spool pieces provided by Intero. This arrangement (Figure 5) created a pathway for deploying the Pipe Explorer 20/26 into and out of the pipelines. This innovative deployment method alleviates the need for permanent infrastructure dedicated to inline inspection, ensuring flexibility and efficiency. The installation of the hot tap fittings was executed as a relatively routine operation, demonstrating the effectiveness of Intero's approach.

The inspection of each pipeline took approximately six hours, a timeframe that was optimized by the use of the Pipe Explorer 20/26, which was deployed while the pipelines continued to operate normally. This efficient inspection process not only preserved the integrity of the pipelines but also demonstrated the advanced capabilities of the robotic system in real-world applications. The successful execution of this inspection highlighted the effectiveness of innovative technologies in overcoming traditional challenges in pipeline maintenance and assessment, ensuring continued operational reliability.
